# Entune Audio Head Unit Software Update (Panasonic)

YEAR(S)	MODEL(S)	ADDITIONAL INFORMATION
2014 – 2015	4Runner, Highlander, Highlander HV, Sequoia, Tacoma, Tundra

The information contained in this bulletin supersedes SB No. T-SB-0006-14.

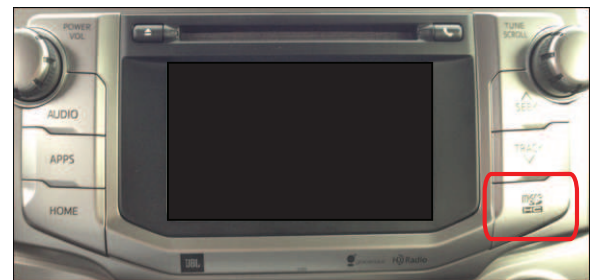
Figure 17.

If update fails and the error message "New software is not compatible with the system." displays, cycle the ignition OFF, remove the Map Micro SD Card from the head unit, and repeat steps 2 – 11.

Software update error is more likely to occur in areas with more traffic information.

Once update is complete, reinsert the Map Micro SD card into the head unit, cycle the ignition OFF, and proceed to step 13.
