Water Leak At Back Door Hatch

Service Category Vehicle Exterior

Section Door/Hatch

YEAR(S)	MODEL(S)	ADDITIONAL INFORMATION
2006 – 2007	Highlander HV	
2001 – 2007	Highlander

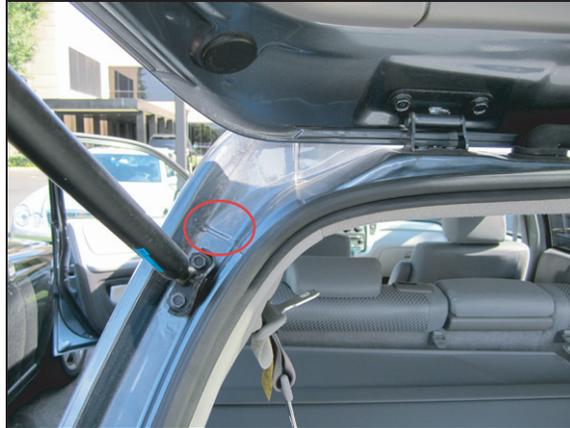
Figure 1.

Some 2001 - 2007 model year Highlander / Highlander HV vehicles may exhibit water intrusion into the rear of the vehicle due to a cracked body seam sealer just above the back door stay mount area. Use the following repair information to address this condition.

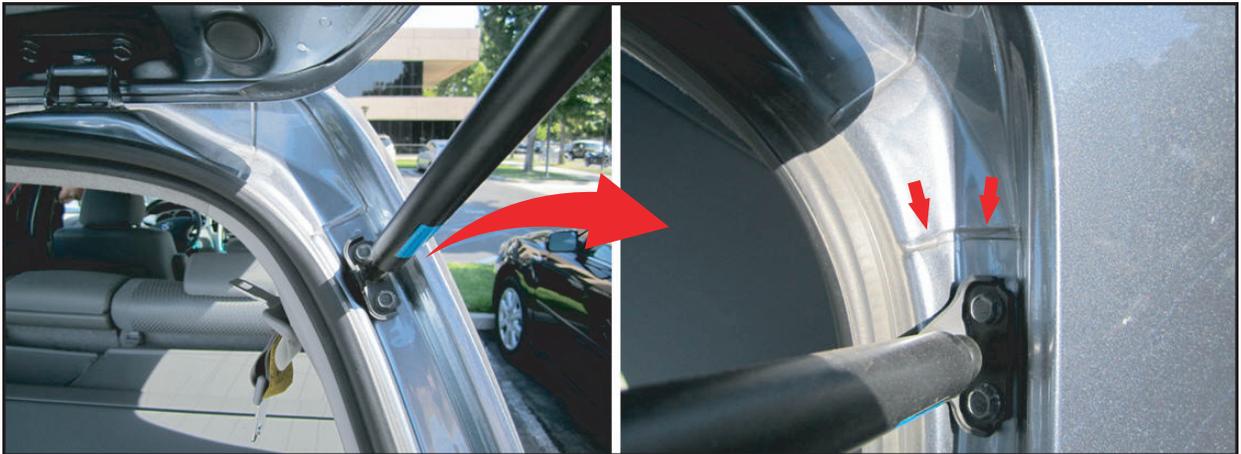
Figure 2.

1. Visually inspect the left and right rear hatch seams above the upper back door stay mounting bracket.

- A. If separation is present, proceed to step 2 of the repair procedure.
 - B. If no separation is present, STOP. The source of water is coming from a different location. This TSB does NOT apply. Continue diagnostics per the Repair Manual.
2. Send the vehicle to the body shop.
 3. Repair the back door seam area by removing the left and right rear hatch stays, back door weatherstrip, and the interior left and right roof side rail garnish sub-assembly in the recommended repair procedures below.

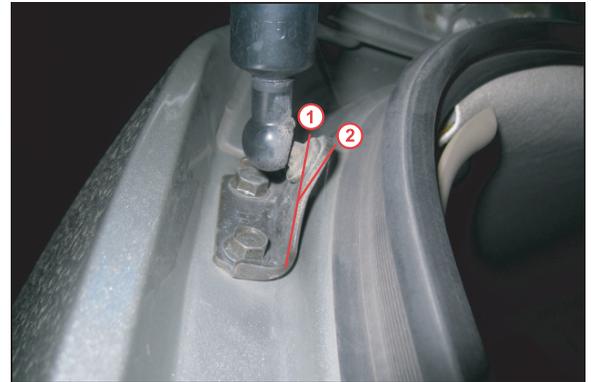
1	Correct
2	Incorrect

12. Apply seam sealer to the weld location and repaint the rear hatch area according to the paint manufacturer's recommendations.
13. Inspect and replace any deformed rear hatch stay brackets as shown in Figure 6.
