Knocking Noise From Fuel Tank Area

Service Category Engine/Hybrid System

Section Fuel System

YEAR(S)	MODEL(S)	ADDITIONAL INFORMATION
2017 - 2019	Highlander

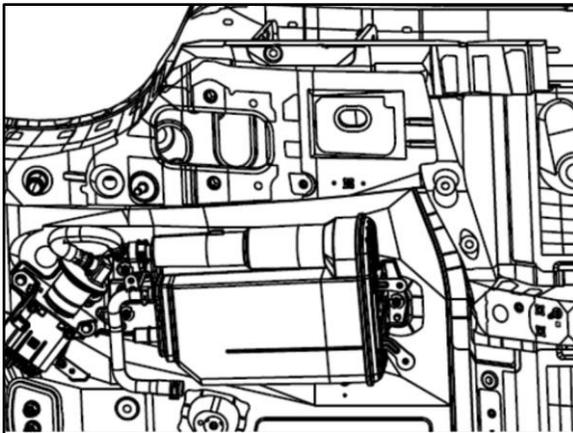
Figure 1. Without Pulsation Damper Valve Assembly Installed

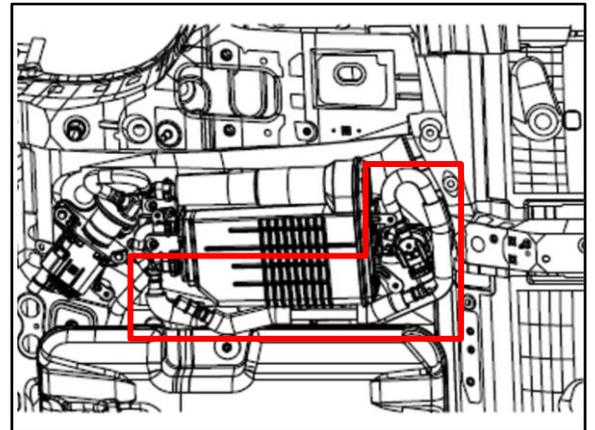
Figure 2. With Pulsation Damper Valve Assembly Installed

The NEW part can be identified by the addition of a bracket and valve assembly attached to the charcoal canister.
