Techstream ECU Flash Reprogramming Procedure

Service Category Engine/Hybrid System

Section Engine Control

The information contained in this bulletin supersedes SB No. T-SB-0012-13.

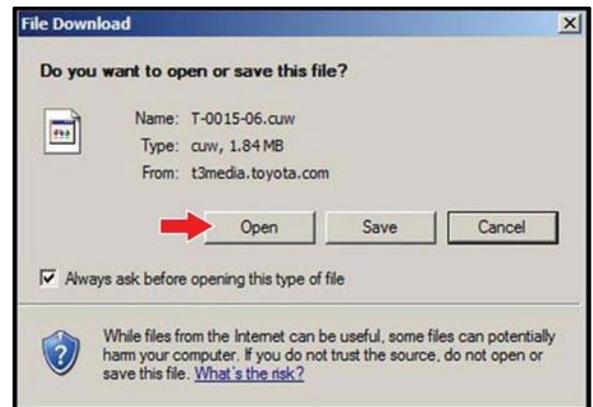
Figure 11.

- B. Click Open to load the calibration file information.

Techstream downloads calibration files as needed to ensure the latest calibration file is used. Do NOT save calibrations locally on the hard drive or other media.

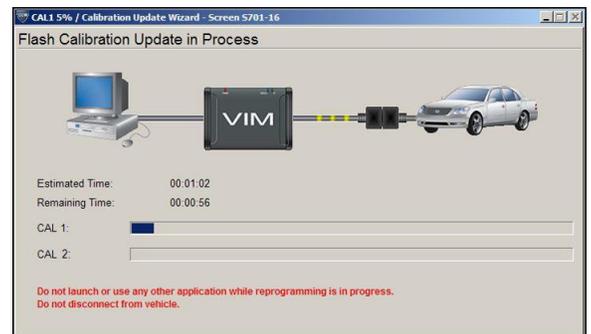
Figure 17.

Do NOT disturb the vehicle during flash reprogramming.

- ECU flash reprogramming may take 3 – 30 minutes per calibration file.
- Reprogramming time will vary depending on model and ECU communication protocol. Vehicles using CAN communication protocol will reprogram much faster (2 – 7 minutes).

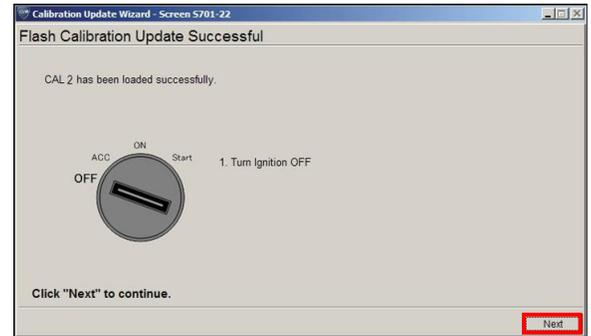
Figure 21.

- K. Turn the ignition OFF for a minimum of 10 seconds, then click Next.

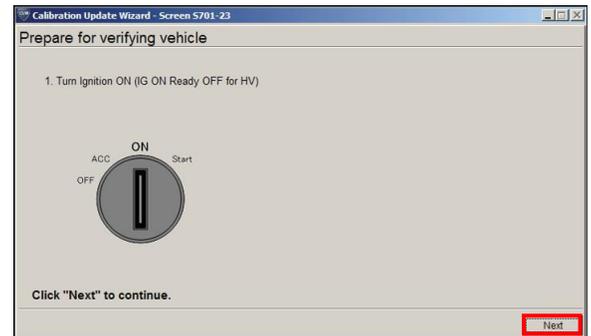
Figure 22.

- L. Turn the ignition to the ON position, then click Next.

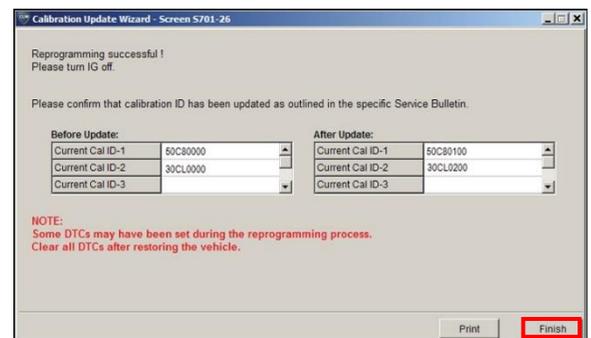
Figure 23.

- M. Confirm ALL calibrations were updated as specified in the Service Bulletin, then click Finish.
